# INVESTIGATION OF FALL PROTECTION FOR RESIDENTIAL ROOF CONSTRUCTION AND REPAIR IN HAWAII

# A THESIS SUBMITTED TO THE GRADUATE DIVISION OF THE UNIVERSITY OF HAWAII IN PARTIAL FULFILLMENT OF THE REQUIREMENTS FOR THE DEGREE OF

**AUGUST 1997**

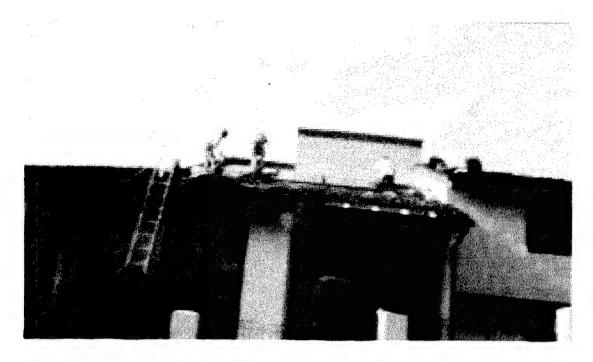
Figure B.1: Partial reroofing project, Aiea; no protection in use

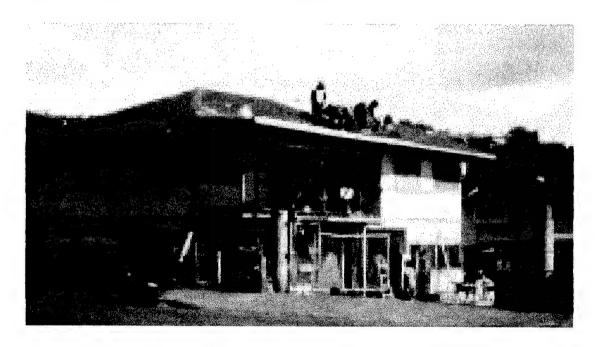
Figure B.4: Renovation project, Honolulu; no protection

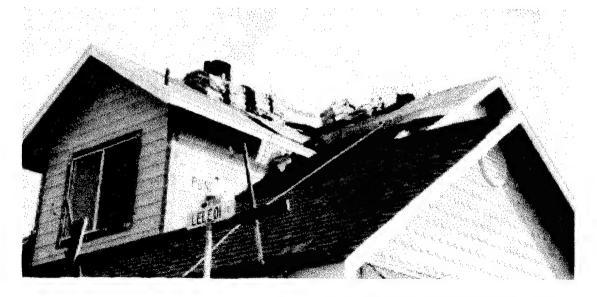
Figure B.6: New construction, Ewa Beach; PR20 Eave Catchguard system and Trus-T PFAS variant, corner view

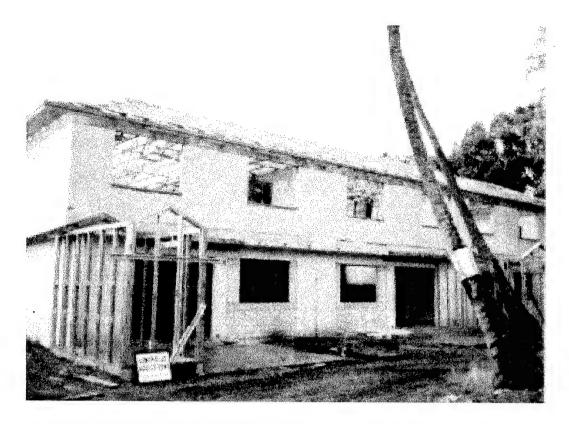
Figure B.9: Renovation project, Hickam Air Force Base; fall protection plan (Note "controlled access zone" sign at left front corner of structure.)

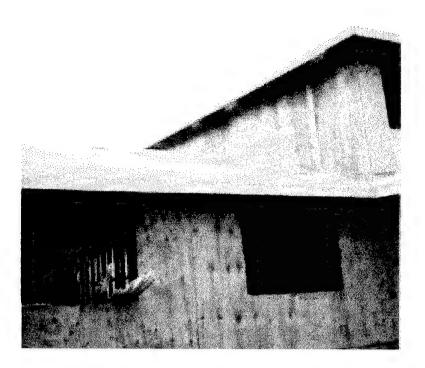
Figure B.13: New construction, Moanalua Navy Family Housing, Pearl Harbor; Safe-T-Strap PFAS variant (Note strap hanging from ridge and proceeding down to right.)

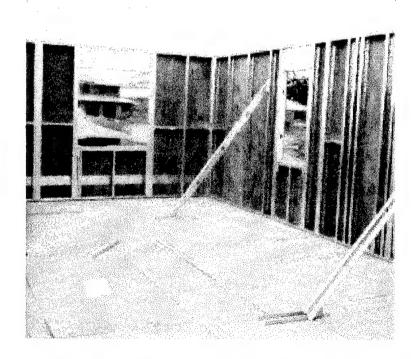
Figure B.14: New construction, Moanalua Navy Family Housing, Pearl Harbor; use of alternative construction sequence to allow for placement of work platforms during truss installation (Note lack of interior frame walls.)

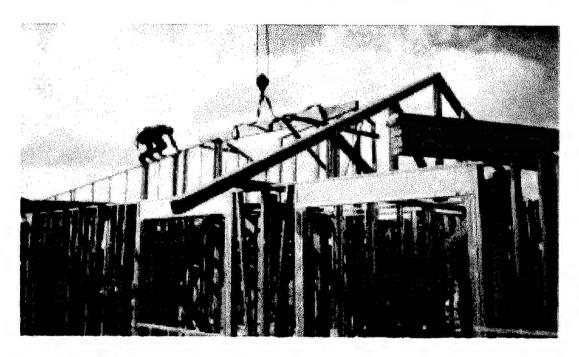
Figure B.18: New construction, central Oahu; fall protection plan; setting the center ridge for half-truss installation (No protection is afforded to the worker.)

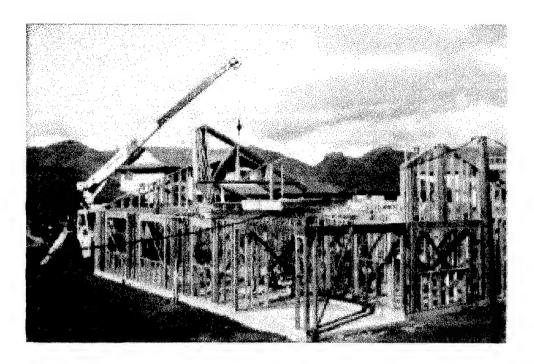
Figure B.19: New construction, central Oahu; fall protection plan; truss delivery and placement on the top plates of frame walls (No protection is afforded to the worker.)

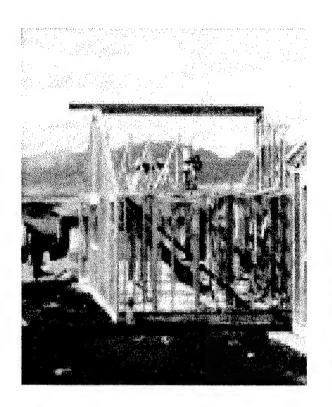
Figure B.21: New construction, central Oahu; fall protection plan; truss installation--setting the trusses

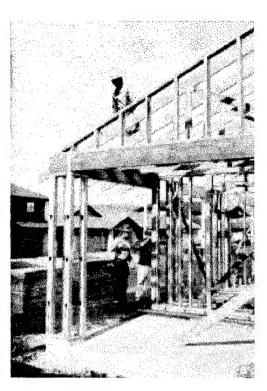
Figure B.22: New construction, central Oahu; fall protection plan; truss installation--walking the top plate
